Manhole Inspection Summary

Manhole # S55A__003MH

Location Address: **3600 pulaski hw** Cross Street: **n conkling st**

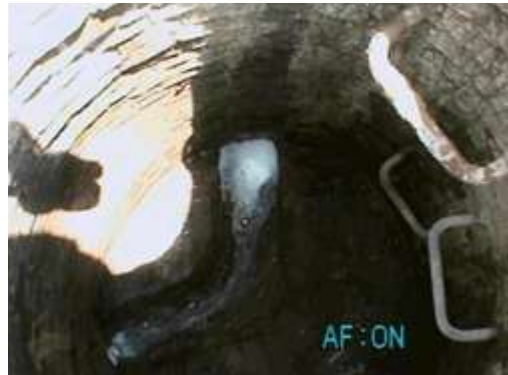
Top View

top view & steps

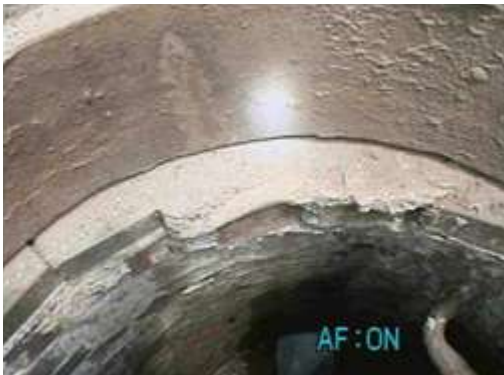
Defect 2

Frame Offset: **2** (in.) Condition: ☒ Sound ☐ Cracked ☐ Leaks

offset

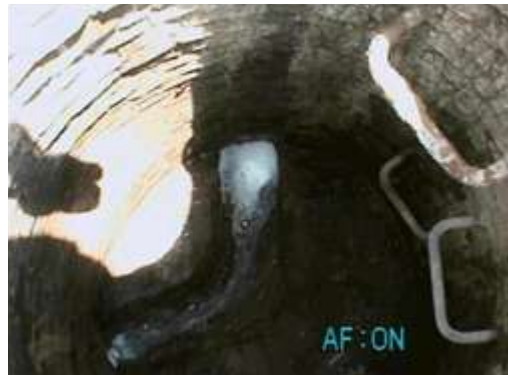
Defect 1

Steps Count: **3** Missing: **0** ☒ **Corroded**

corroded steps

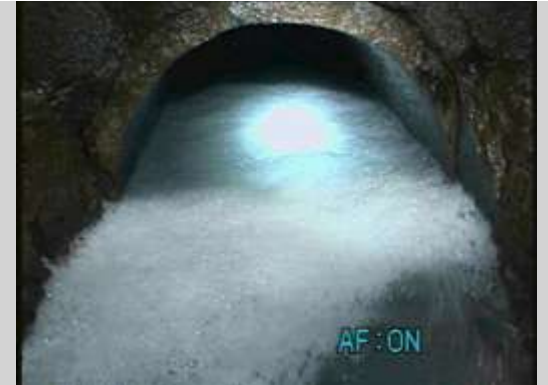
12 O'Clock Outflow

8 in. Circular Gravity Sewer
Pipe Out @ 12 O'Clock

Pipe Material: **Clay** ☐ Pipe Lined

Invert Depth: 7.49 (ft.) Flow Characteristics: **Fast**

Deposits: ☒ None ☐ Mud ☐ Sludge ☐ Debris ☐ Grease

Infiltration: **None**

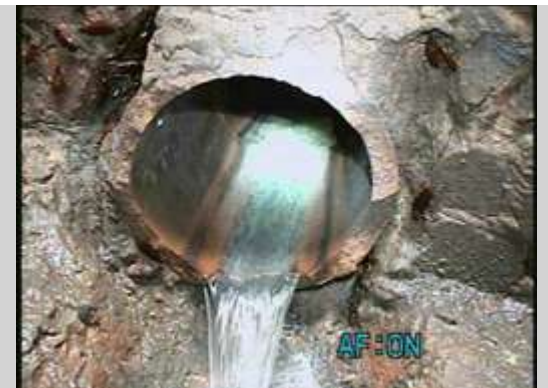
9 O'Clock Inflow

8 in. Circular Gravity Sewer
Pipe In @ 9 O'Clock

Pipe Material: **Clay** ☐ Pipe Lined

Invert Depth: 7.33 (ft.) Flow Characteristics: **Fast**

Deposits: ☒ None ☐ Mud ☐ Sludge ☐ Debris ☐ Grease

Infiltration: **None**
